Site 10 Salisbury Beach Reservation – Access Road

Great Marsh Coastal Wetlands Restoration Planning

CZM Rapid Field Assessment

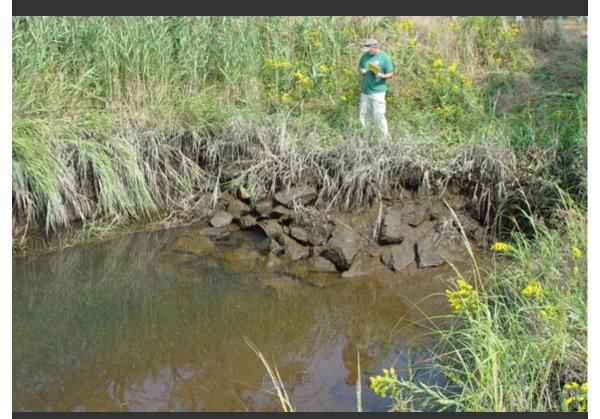
Structure conditions: The first culvert under the access road (Culvert 1) is located approximately 1,200 ft south of Beach Road. Culvert 2 is located approximately 600 ft further south of Culvert 1. The access road is approximately 5.5 ft above the surrounding salt marsh and is in good condition. Culvert 1 is a 36 in CMP pipe with riprap outlet protection and is approximately 120 ft long. The downstream riprap is beginning to fail and is falling into the existing scour hole. The upstream pipe invert has advanced signs of corrosion and deterioration. Holes are present in the pipe, and a portion of the pipe has rusted away. The upstream creek showed signs of sediment buildup. Sanding operations at the municipal parking lot might be a contributing factor. Overall, Culvert 1 is in poor condition.

Photo 4 - Downstream View of Northern Culvert Under Access Road

Overall, the existing impairments are considered severe. Replacing the existing culverts under the access road with larger structures set lower in the channel would reduce the tidal restriction, the observed bank erosion, and the impounded channel conditions. The increased tidal exchange along with additional ditch work on the marsh would help limit the expansion of the populations of *Phragmites* and allow the marsh plain to increase in elevation in response to rises in sea level. Major impacts to abutting developed lands are anticipated without appropriate mitigating measures such as self regulating tide gates (SRTs).

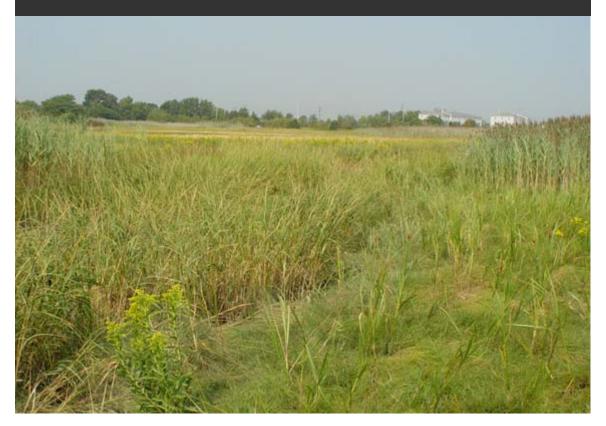
The replacement of the third culvert under Beach Road was not considered practical and therefore not closely inspected. This culvert is a 24 in RCP pipe and is approximately 280 ft in length. The ditch north of Beach Road is partially obstructed with accumulated sediment.

Photo 7 - Upstream View of Culvert Under Beach Road

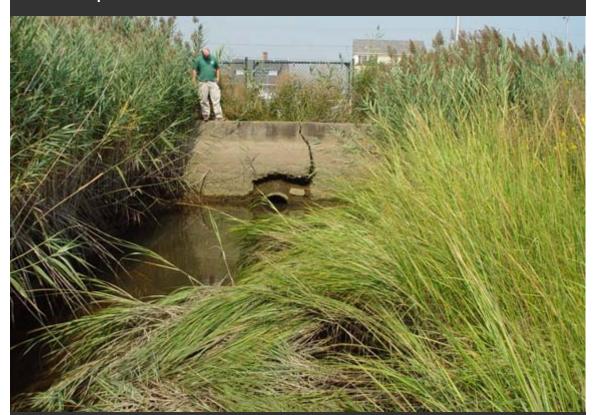
Photo 8 - Creek North of Beach Road Viewing North
